PART NO. 52-943/52-943BK

CALIPER COVERS

FITMENT: HONDA GOLDWING/GOLDWING TOUR-2018-NEWER

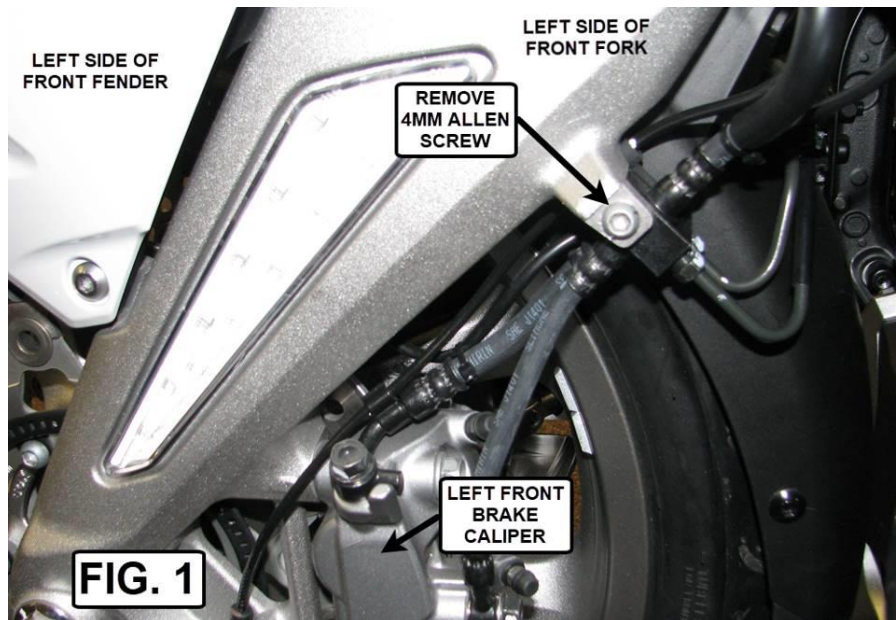
1. STARTING ON THE LEFT SIDE OF THE BIKE, USE A 4MM ALLEN WRENCH TO REMOVE THE SCREW SHOWN IN FIG. 1. (SCREW WILL NOT BE REUSED)
2. REMOVE THE TWO BOLTS AT THE END OF THE LEFT FORK (FIG. 2) AND SET ASIDE FOR NOW.

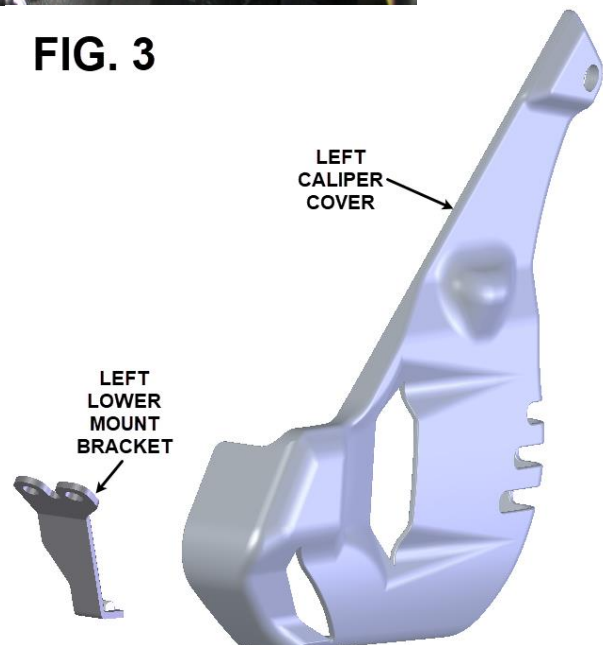
**FIG. 3**

3. USE FIG. 3 TO DETERMINE THE LEFT SIDE CALIPER COVER AND LEFT LOWER MOUNT BRACKET. SET THE RIGHT CALIPER COVER AND LOWER MOUNT BRACKET ASIDE FOR NOW.

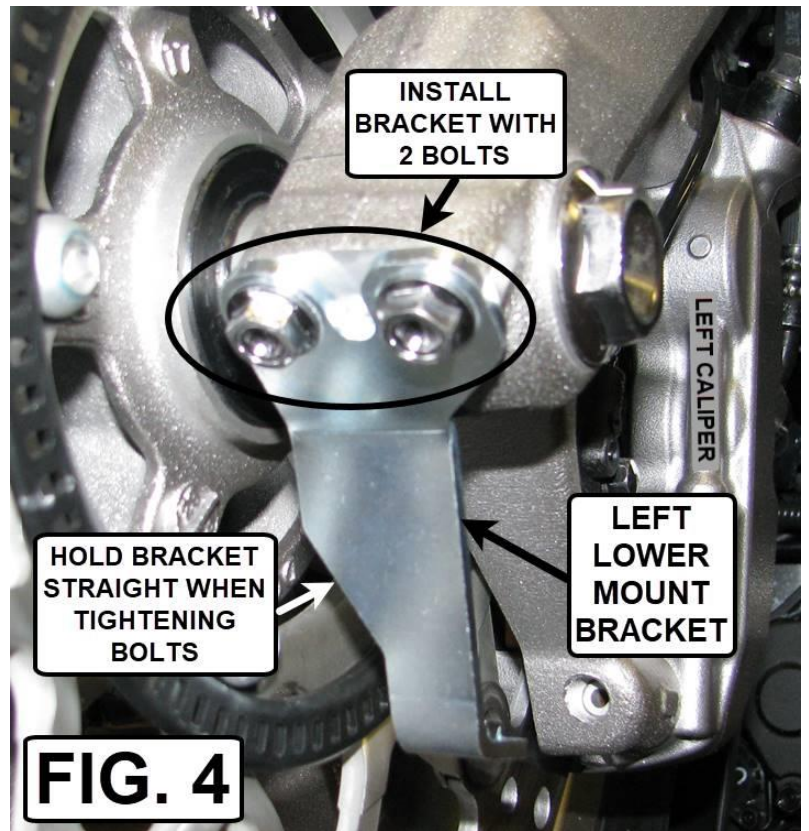
4. INSTALL THE LEFT LOWER MOUNT BRACKET AS SHOWN IN FIG. 4 USING THE TWO BOLTS THAT YOU REMOVED IN STEP 2, HOLDING THE BRACKET STRAIGHT WHEN TIGHTENING. (16 FOOT POUNDS) BRACKET MAY FLEX DOWNWARD SLIGHTLY WHEN TIGHTENED; IF NECESSARY, THE BOTTOM OF THE BRACKET MAY BE PUSHED UP SLIGHTLY TO ALIGN WITH THE SLOT IN THE CALIPER COVER AS WELL AS ALIGN WITH THE INSIDE SURFACE. (WHEN INSTALLED, THE BRACKET SHOULD LINE UP WITH THE BOTTOM INSIDE SURFACE OF THE COVER. IF THE BOTTOM OF THE BRACKET IS TOO HIGH OR TOO LOW, IT COULD STRESS THE BOTTOM OF THE COVER AND CAUSE DAMAGE.)

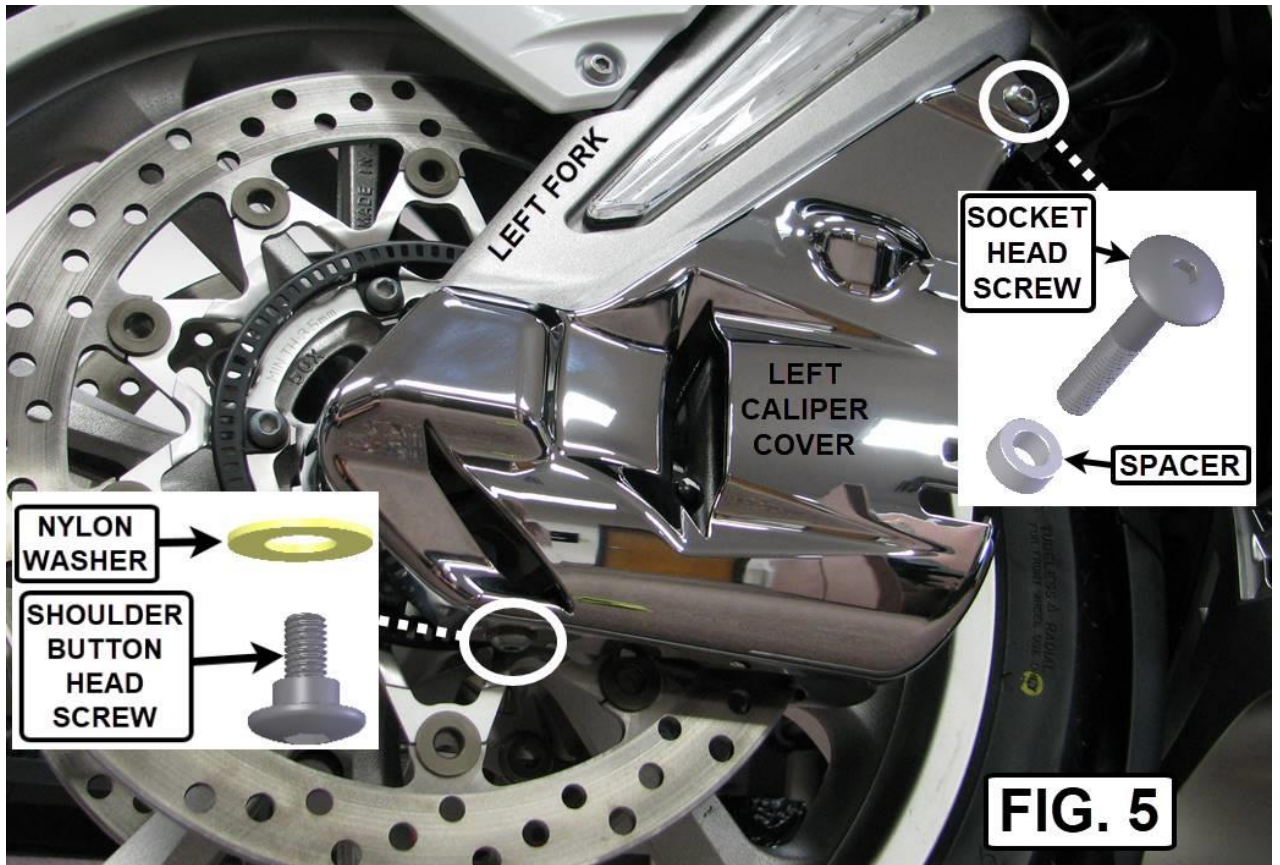
5. USING THE SUPPLIED HARDWARE, INSTALL THE LEFT CALIPER COVER ON THE BIKE ACCORDING TO FIG. 5.
6. REPEAT STEPS 1 THROUGH 5 ON THE RIGHT SIDE.
